UNIVERSITY OF WISCONSIN WHITEWATER

COMPREHENSIVE CAMPUS MASTER PLAN

DFD PROJECT NO. 1211D

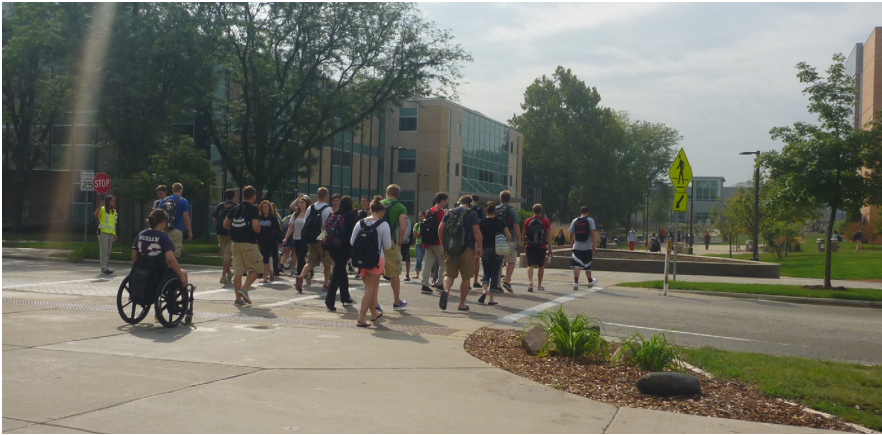
FIGURE 1 - PEDESTRIANS CROSSING STARIN RD

Starin Road between Prince Street and Prairie Street is a section of roadway where motor vehicle congestion and queuing were observed. In general, Starin Road serves the multiple modes of transportation adequately. During periods of high volume pedestrian crossings, conflicts arise. Figure 1 shows one of the high volume pedestrian crossings of Starin Road.

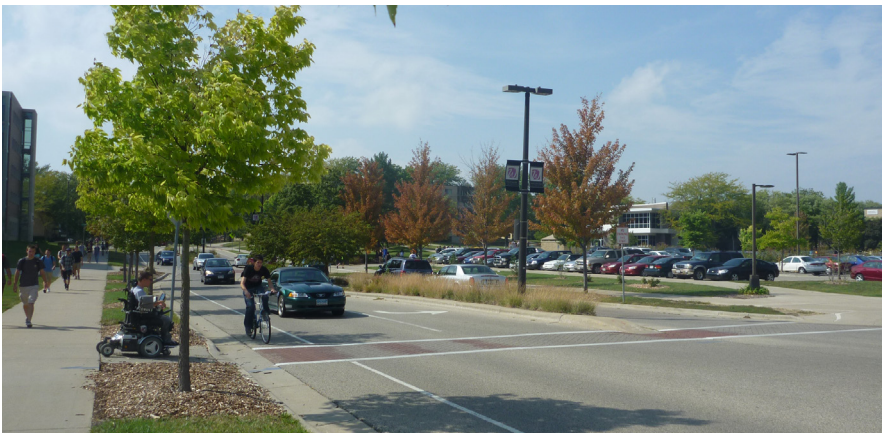
FIGURE 2 - STARIN RD AT WARHAWK DR.

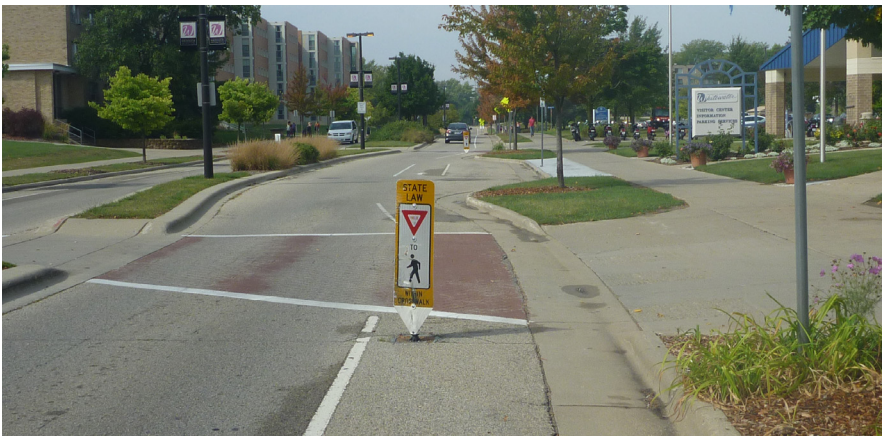
FIGURE 3 - SIGN INFRINGING IN BICYCLE LANE

While on-street bike lanes are marked along Starin Road, at the major pedestrian crossings they are partially blocked by "Yield to Pedestrian" signage (see Figure 3). This may encourage some bicyclists to ride on the sidewalk, which was also observed during the site review.

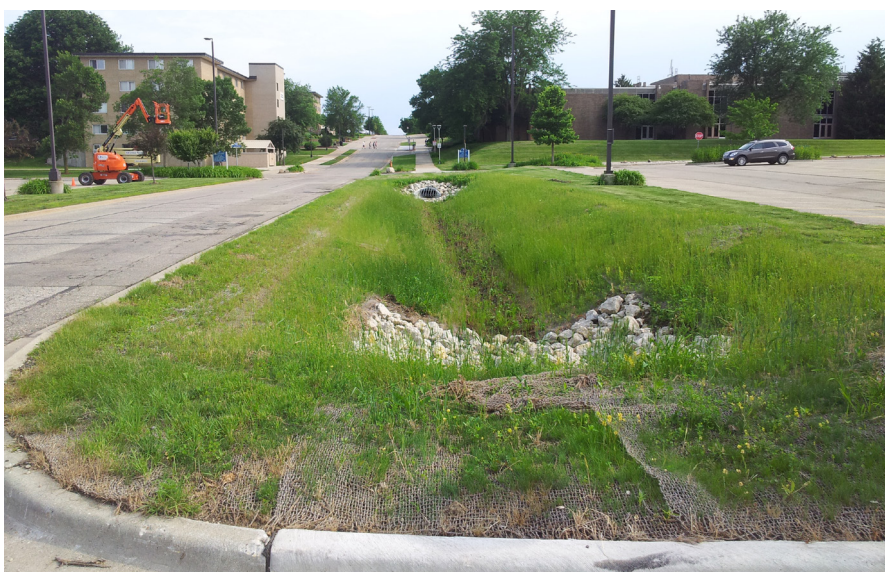
FIGURE 1 - FLOOD RELIEF BIOSWALE - PRAIRIE ST.

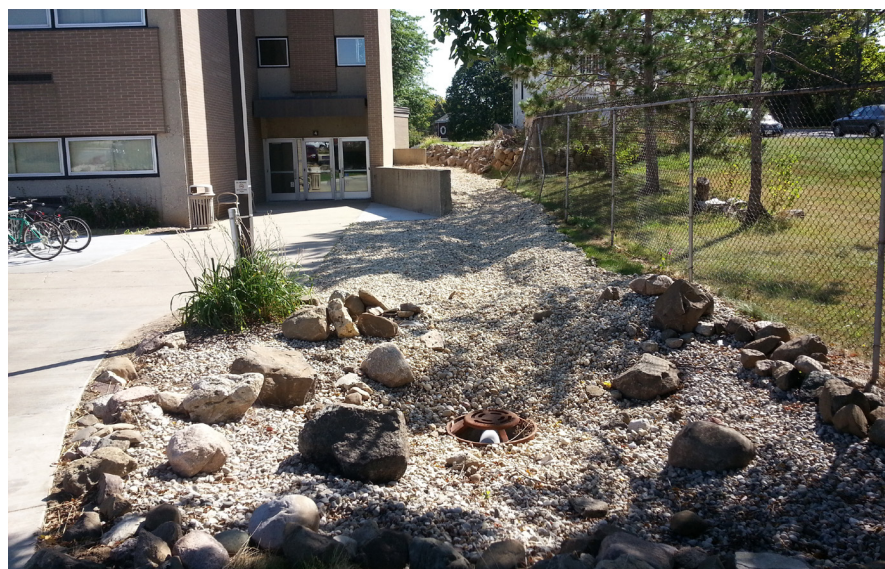
FIGURE 2-HEIDE HALL STORMWATER IMPROVEMENTS

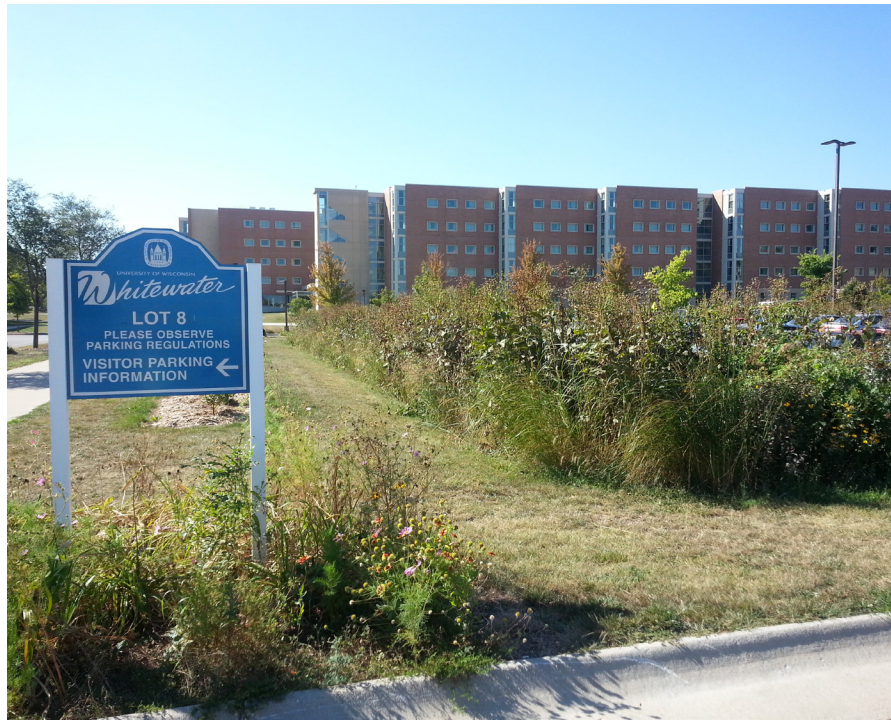
FIGURE 4 - LOT 8 BIORETENTION BASIN

From a stormwater treatment standpoint, existing BMPs include street sweeping, two bioretention basins serving Parking Lot 8 (drainage basin WC-5) as shown on Figure 4, one bioretention basin serving Parking Lot 2 (drainage basin WC-57.1) as shown in Figure 5, and a wet detention basin serving sports fields and the track (drainage basin WC-58.1).

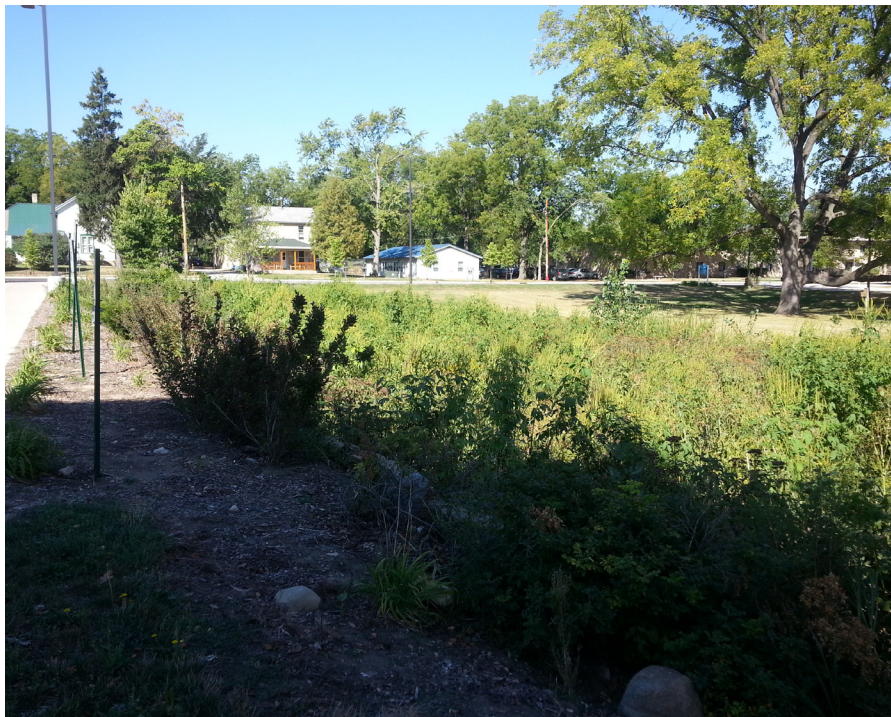
FIGURE 5 - LOT 2 BIORETENTION BASIN

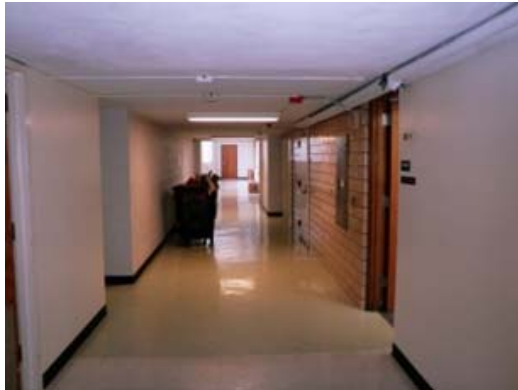
Figure 1, ground floor corridor between 1952 bldg and 1964 bldg.

Library floor 1	C	C	B	C	C	C	C	The library functions on this floor underutilize this space. Access to this floor is awkward. This area could be repurposed for other uses.	Fig. 1, 17, 18, 19
Communications Dept., Cable TV station	B	B	B	B	C	B	B	Better identification of entrances to these areas and better interior wayfinding signage is needed.	Fig. 3, 4, 6, 19
Student study and meeting areas	B	B	B	B	B	B	B	Several people requested that more of this type of space be constructed.	Fig. 11, 16
Library floor 2	B	B	B	B	C	B	B	This is the main floor of the library, and the level that gets the highest use. Better configuration of the entrance/collection control point to this area would improve its functionality.	Fig. 13, 14, 15
Library floor 3	C	C	B	B	B	B	C	This is an underutilized, very large space. This area could be repurposed for other uses.	Fig. 5, 8

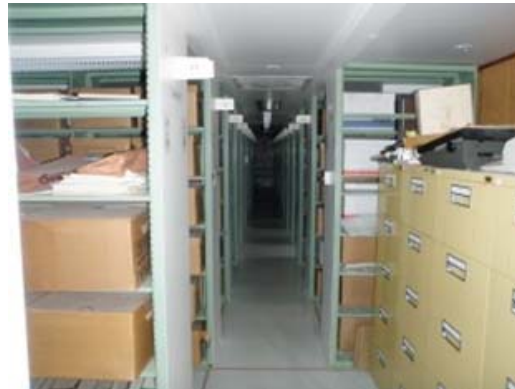
Figure 5, high density storage, 2nd floor of 1952 bldg.

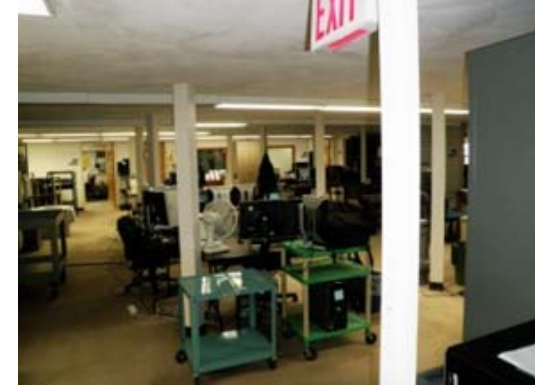
Figure 6, 2nd floor of 1952 bldg, high density storage area converted to office space for IT Department.

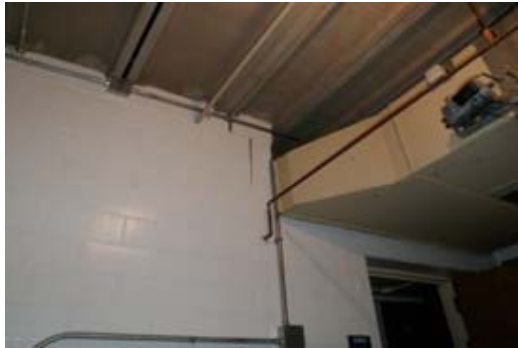
Figure 7, cracked CMU in 1952 bldg mech penthouse.

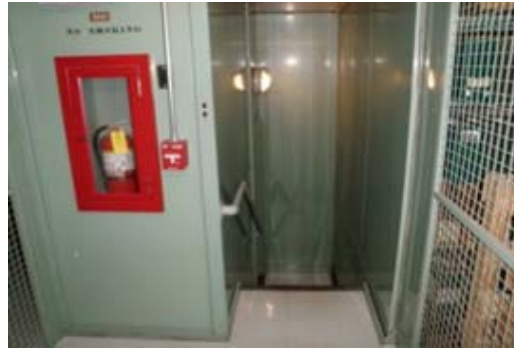
Figure 8, access stair in 1952 bldg high density storage.

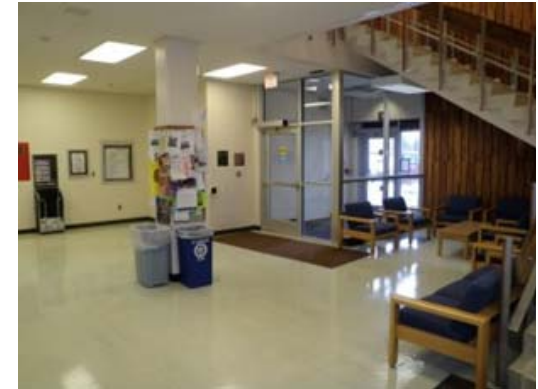
Figure 9, 1st floor library entry at 1962 building.

<i>COMPONENT</i>	CONFIGURATION/LAYOUT	SPACE UTILIZATION	ADAPTABILITY/FLEXIBILITY	INFRASTRUCTURE	ACCESSIBILITY	CODE & LIFE SAFETY	OVERALL	<i>REMARKS</i>	<i>PHOTOS</i>
Site/Entry Location/Access	B	C	B	B	B	B	B	Connectivity to campus circulation routes, both exterior and interior, were reported by users as appropriate. Some users suggested that the library functions would better serve campus if the library was centrally located on campus.	
Center for Students with Disabilities Entry/Common Area	B	B	B	B	B	B	B	This area was remodeled in the last decade. Occupants reported that the physical environment was good, but they needed more space.	Fig. 2
IT Office and Support Areas	C	C	B	C	C	B	C	IT areas seem to be backfilled “leftover” spaces. IT space that is remodeled in a more holistic way would better serve this user group.	Fig. 6
Library Lobby	C	C	B	C	C	C	C	Current library lobby and collection circulation control is very awkward with collections on 3 levels connected by a stairway controlled by delayed egress door hardware.	Fig. 9, 10, 12

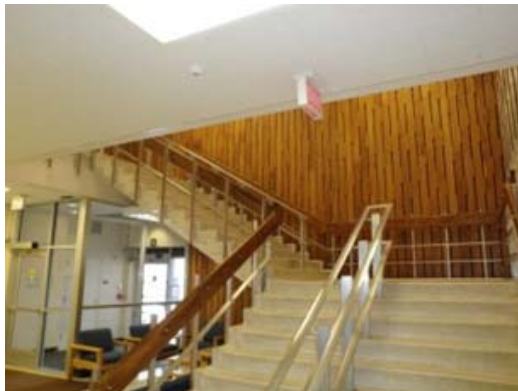
Figure 10, main stair from 1st floor to 2nd floor, 1962 bldg.

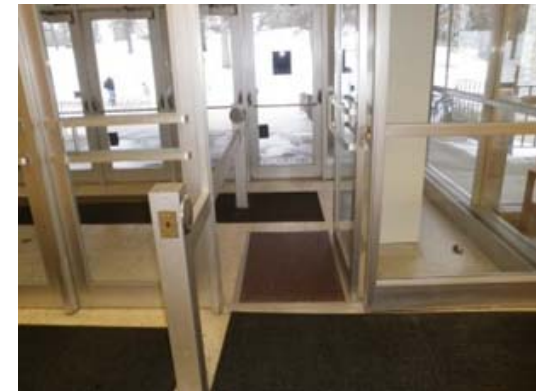
Figure 12, 1st floor entry at link btwn 1951 and 1962 bldg.

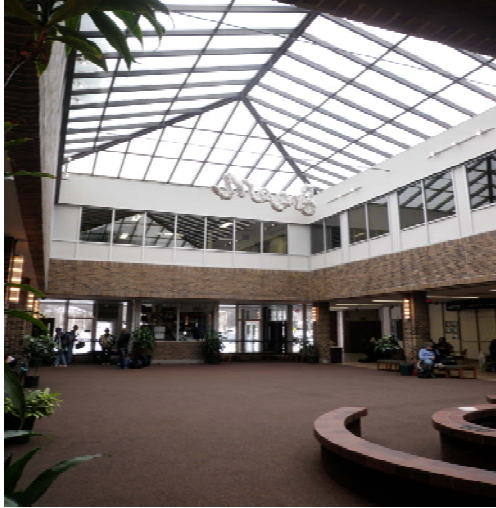
Figure 1, atrium

Atrium	C	C	C	C	C	C	C	The enclosure of this space in 1994 improved the opportunity for better use of this space. Campus report that this space is used frequently for pre-event gathering area, impromptu performances, student study areas, social gatherings and extended gallery space.	Fig. 1, 4, 5
Elevator	C	C	C	C	C	C	C	An elevator was added to this building as an external, stand-alone element in 1994 to provide a vertical accessible route in the building. Incorporating a new elevator or two in a more integrated way as part of a major entrance remodeling would provide better energy efficiency to the enclosure, and better, clearer access to all spaces in the building.	Fig. 8

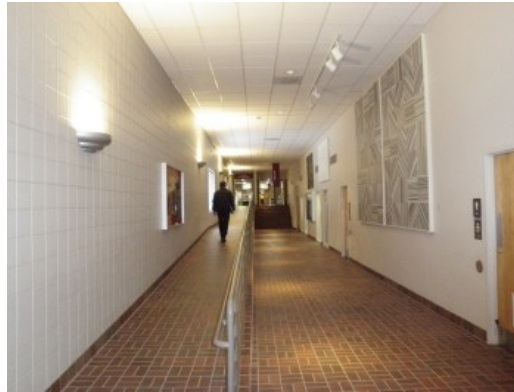
Figure 2, internal circulation ramp next to "flat" circulation

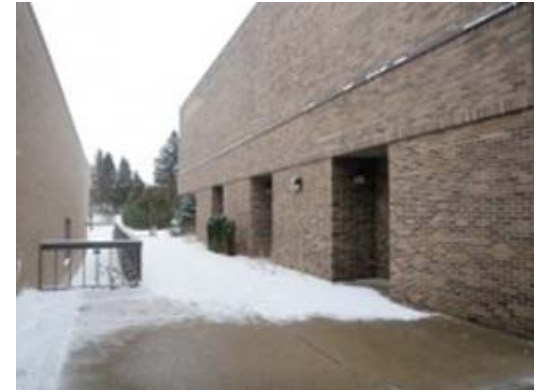
Figure 3, east entry between Young Auditorium and Center of the Arts

CONFIGURATION/LAYOUT	SPACE UTILIZATION	ADAPTABILITY/FLEXIBILITY	INFRASTRUCTURE	ACCESSIBILITY	CODE & LIFE SAFETY	OVERALL	REMARKS	PHOTOS
Interior Finishes	D	D	D	D	D	D	D	Interior finishes are original to the building, are worn, drab, un-inspirational, and should be replaced.	Fig. 1- 2, Fig. 4-13
MEP Systems	C	C	C	C	C	C	C	Review of MEP Systems was not part of this study, but MEP Systems appear to be original to the building and past their practical lifespan. Corridor lighting was replaced in 2014. Lighting fixtures that provide light density, color, and controllability in a manner more appropriate to creating and displaying art should be installed in this building.	
Exterior envelope	C	C	C	C	C	C	C	The exterior envelope is in good condition, but has thermal properties that are much lower performing than what would be constructed today. Construction drawings for the original building do not indicate the presence of any insulation on exterior walls, nor any air spaces. Some insulation was added to spandrel glass areas and roofing in 1987. A building constructed today would have daylighting to occupied spaces.	Fig. 3

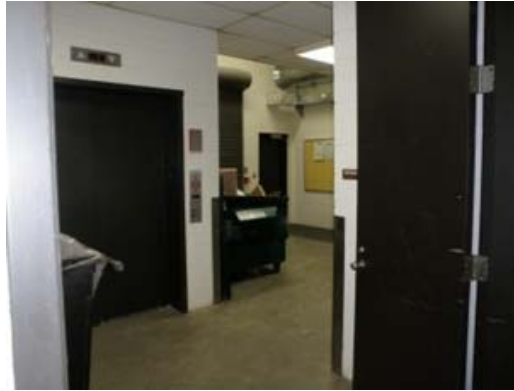
Figure 8, freight elevator, service area

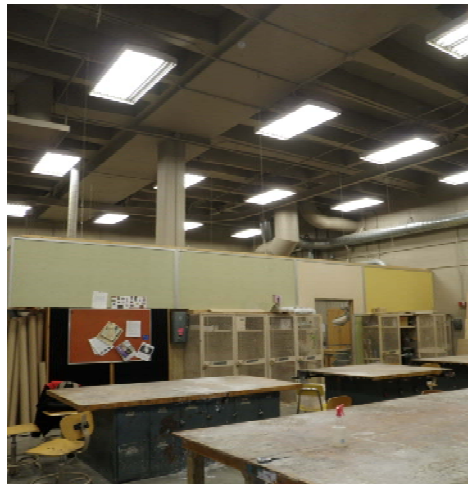
Figure 11, first floor, sculpture lab

CONFIGURATION/LAYOUT	SPACE UTILIZATION	ADAPTABILITY/FLEXIBILITY	INFRASTRUCTURE	ACCESSIBILITY	CODE & LIFE SAFETY	OVERALL	REMARKS	PHOTOS
Site/Entry Location/Access	C	C	C	C	C	C	C	Like other buildings of this era on campus the Greenhill Center of the Arts has its main entrance oriented toward the street rather than to current internal pedestrian circulation routes, although the west entrance did get some upgrades when the Young Auditorium addition was built.	
Performance Spaces	B	B	B	B	C	B	B	Performance spaces appear to be in good condition, but seem to have had little in the way of performance A/V and technology upgrades since the building was constructed in 1970.	
Studios	D	D	D	D	D	D	D	Most studio spaces have no access to daylight, and spaces with no daylight are unpleasant to be in for long periods of time. Studios appear to have original finishes and lighting, which are drab and un-inspirational.	Fig. 11, 12, 13

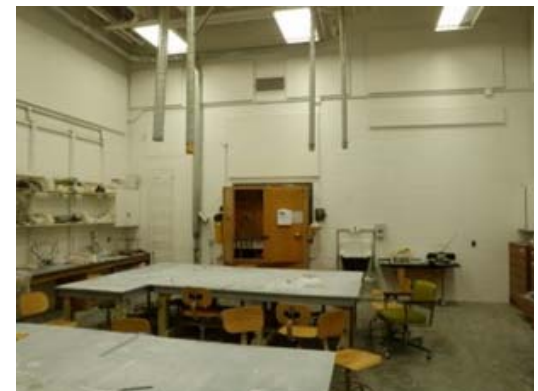
Figure 12, first floor, ceramics lab

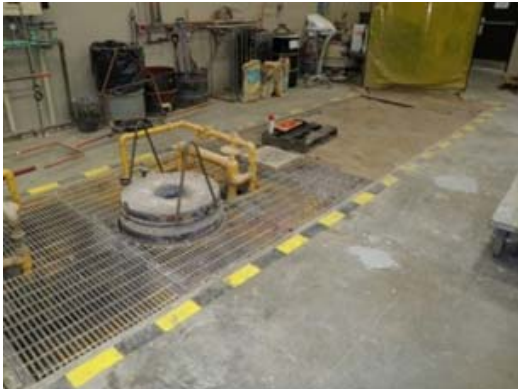
Figure 13, metals casting lab

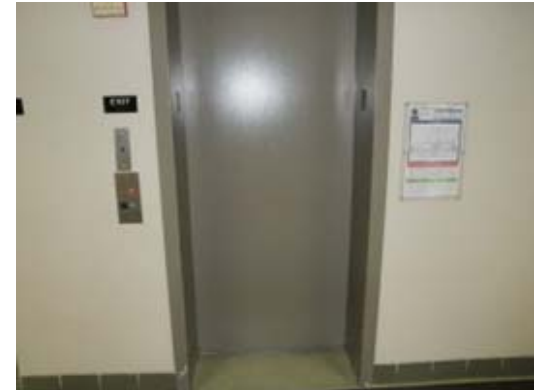
Figure 3, original elevator.

no furnishings, finishes or architectural elements on upper floor hallways that would better facilitate informal student gathering/study activities.	
Elevator	D	D	D	D	D	D	D	Elevator is original to the 1965 building. Size is the minimum required to meet accessibility requirements and is not capable of servicing high volumes of traffic. If an entry improvement is constructed new elevators should be provided as part of it.	Fig. 3
Interior Finishes	C	C	C	C	C	C	C	With a few exceptions noted above, interior finishes and lighting are original to the building, are worn, drab, un-inspirational, and should be replaced.	Fig. 1-17
MEP Systems	C	C	C	C	C	C	C	Review of MEP Systems was not part of this study, but MEP Systems appear to be original to the building and past their practical lifespan, except for lecture hall HVAC, which was replaced as part of the 2011 lecture hall remodeling project.	
Exterior Envelope	C	C	C	C	C	C	C	The exterior envelope is in good condition, but has original 1965 windows and insulation, which are lower performing than what would be constructed today. Replacing the yellowed plastic glazing in the skylight over the lecture hall wing entry would help improve daylighting and aesthetics. Adding airlock vestibules to the north and south stairs would improve comfort and efficiency.

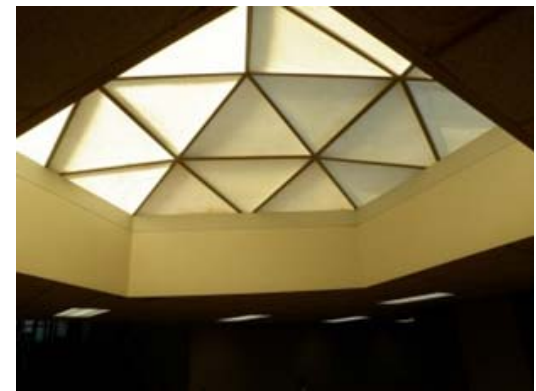
Figure 6, translucent skylight, main entry, east side.

The exterior envelope is in good condition, but has original 1965 windows (which are leaking) and insulation, which are lower performing than what would be constructed today. Replacing the yellowed plastic glazing in the skylight over the lecture hall wing entry would help improve daylighting and aesthetics. Adding airlock vestibules to the north and south stairs would improve comfort and efficiency. There are some water infiltration issues that need to be addressed at some below grade areas.

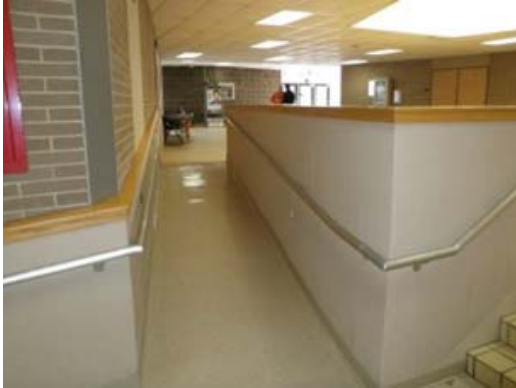
Figure 7, ramp from east side entry to first floor.

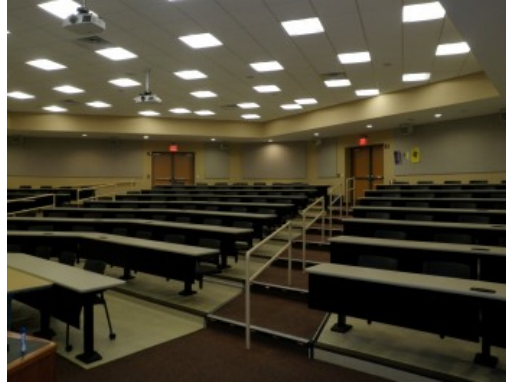
Figure 8, remodeled tiered lecture hall.

<i>COMPONENT</i>	CONFIGURATION/LAYOUT	SPACE UTILIZATION	ADAPTABILITY/FLEXIBILITY	INFRASTRUCTURE	ACCESSIBILITY	CODE & LIFE SAFETY	OVERALL	REMARKS	PHOTOS
Site/Entry Location/Access	C	C	C	C	C	B	C	The “main entry” of this building is oriented to North Prairie Street, but most people access this building from the internal campus side at the north entry.	Fig. 1, 2,4
Internal Circulation	B	B	B	B	B	B	B	Internal circulation is simple and easy to navigate. Size of circulation spaces are adequate. The stairways act as vestibules at the northwest and southwest entries which are not energy efficient.	Fig. 2, 5, 7, 9, 11, 12, 13, 14, 16
Classrooms	C	C	C	C	C	C	C	Classroom sizes and shape are compatible with many current instructional setups. Technology and lighting need major upgrades. Finishes are original to the building and un-inspirational.	Fig. 10
Lecture Rooms	B	B	B	B	B	B	B	The lecture halls had technology, finish and accessibility upgrades within the last decade.	Fig. 8

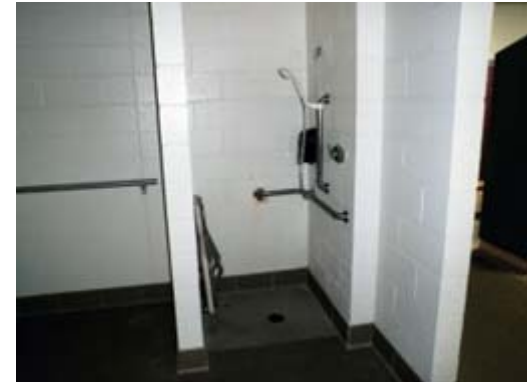
Figure 15, accessible shower.

Locker Rooms	D	D	D	D	D	D	D	Aside from some very basic revisions to improve accessibility locker rooms are original to the building; worn, cramped, hard to navigate and provide little privacy. These areas should be completely gutted and remodeled.	Fig. 15, 16, 17, 18, 19
Offices	B	B	B	B	B	B	B	Office spaces within Williams Center have been upgraded and appear to meet modern standards for technology, although space allocations and arrangement remains largely the same as when the building was constructed.	
Toilet Rooms	D	D	D	D	D	D	D	The addition of the Kachel Fieldhouse greatly improved toilet rooms outside of the locker rooms. Toilet rooms inside the locker rooms are original, don't meet accessibility requirements, and should be replaced as part of a locker room gut rehab.	Fig. 17

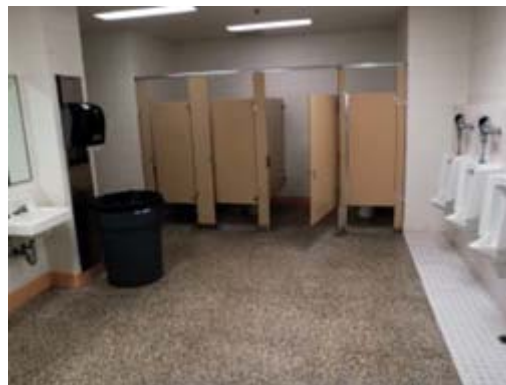
Figure 17, men's locker room.

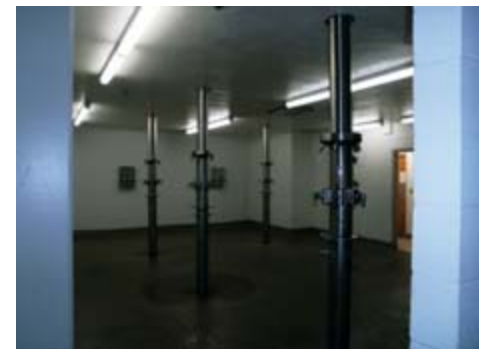
Figure 18, men's shower room.

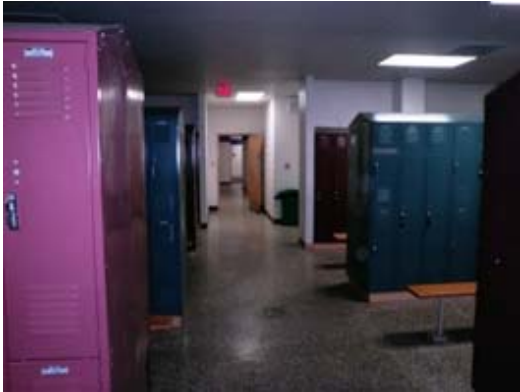
Figure 19, men's locker room.

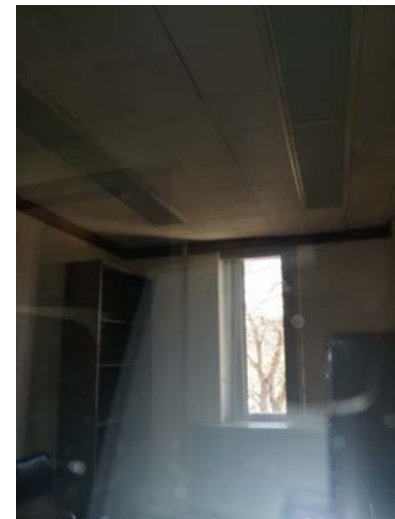
Figure 6, faculty office.

<i>COMPONENT</i>	CONFIGURATION/LAYOUT	SPACE UTILIZATION	ADAPTABILITY/FLEXIBILITY	INFRASTRUCTURE	ACCESSIBILITY	CODE & LIFE SAFETY	OVERALL	<i>REMARKS</i>	<i>PHOTOS</i>
Site/Entry Location/Access	C	C	C	C	C	B	C	The “raised” entry level of this building and half story exit to the south is not the best configuration for accessible routes to this building. The “street entrance” oriented to N Prairie Street does not serve current circulation patterns on campus.	Fig. 9
Lecture Halls	B	B	B	B	B	B	B	Finishes, lighting, and AV systems were updated in these areas in 2001.	Fig. 3
Classrooms/Labs	D	D	D	D	D	D	D	Classrooms/Labs have original 1967 finishes, MEP systems, lighting, and instructional fixtures – these are extremely obsolete. None of the classrooms/labs have access to daylight, and spaces with no daylight are unpleasant to be in for long periods of time.	Fig. 1, 2, 4
Offices	C	C	C	C	C	C	C	Office configuration is original to the 1967 building, and modern office configurations are quite different in terms of size, configuration, and support spaces. Partitions are constructed of concrete block, which is institutional looking and not easy to reconfigure. Finishes are worn and uninspiring.	Fig. 5, 6

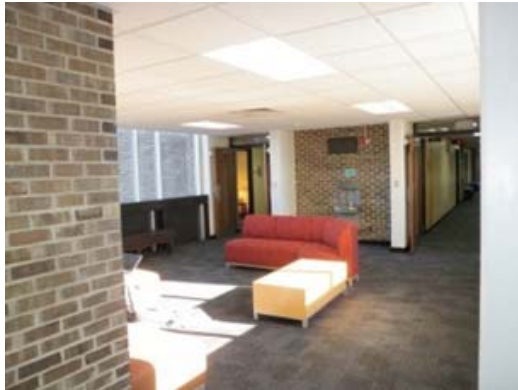
Figure 7, study lounge.

Study & Breakout areas	C	C	C	C	C	C	C	Furnishings have been provided in several areas to facilitate informal breakout and study functions, but no purposely defined spaces exist for these functions.	Fig. 7, 8
Toilet Rooms	F	F	F	F	F	F	F	Existing toilet rooms are original to the building, are not accessible, and rooms for each gender are not provided on every floor. All existing toilet rooms should be removed and replaced elsewhere.	Fig. 12, 13
Circulation at Instructional Spaces	C	C	C	C	C	C	C	Some areas of existing circulation are used for informal study spaces, while other circulation areas are too narrow to accommodate classroom turnover effectively. Remodeling these areas in conjunction with replacing bathrooms and adding study space could remediate these deficiencies.	Fig. 11

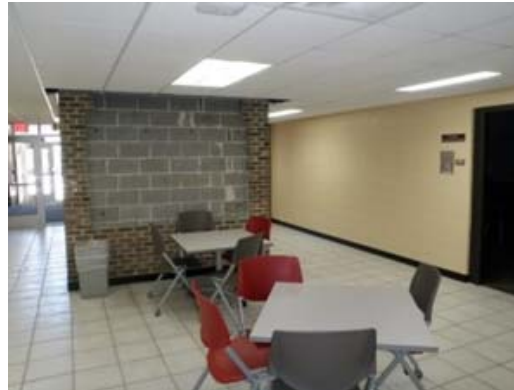
Figure 8, study lounge.

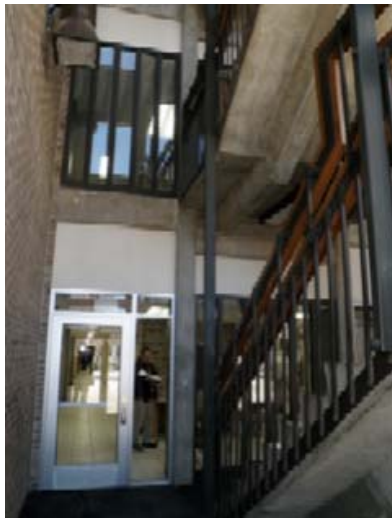
Figure 10, monumental stair.

<i>COMPONENT</i>	CONFIGURATION/LAYOUT	SPACE UTILIZATION	ADAPTABILITY/FLEXIBILITY	INFRASTRUCTURE	ACCESSIBILITY	CODE & LIFE SAFETY	OVERALL	<i>REMARKS</i>	<i>PHOTOS</i>
Monumental Stair (east side of classroom wing)	C	C	C	C	C	C	C	The east side of the building was designed as a main entrance, but campus circulation patterns have changed, and the entrance on the north is now the most heavily used. Lighting and finishes in both stairs are dated and gloomy. The current configuration in which the east stair tower is essentially the vestibule for this entrance is not energy efficient.	Fig. 10
Circulation at Office Spaces	C	C	C	C	C	C	C	Entrance zones of the office floors are cramped. Corridors are narrow and long. Finishes and lighting are original to the building and un-inspirational.	
Elevator	F	F	F	F	F	F	F	Elevator should be replaced as part of a building remodeling. Elevator is original to the building, does not meet accessibility requirements, and does not adequately handle traffic volume.

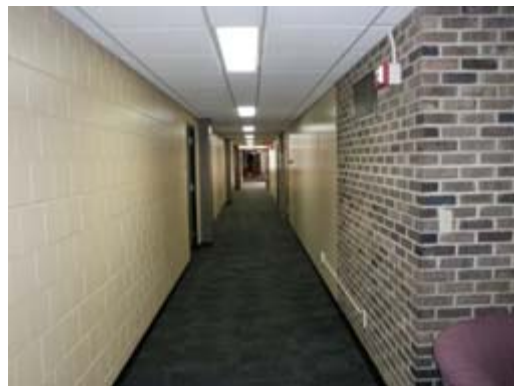
Figure 11, corridor in classroom wing.

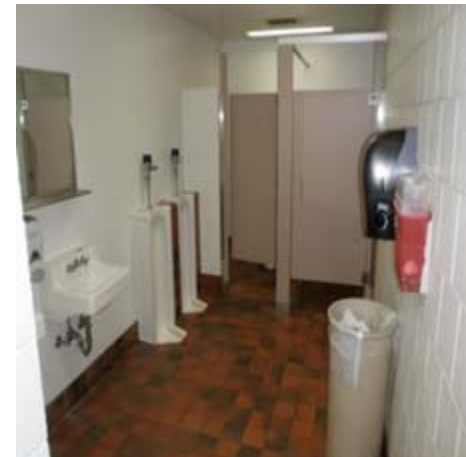
Figure 12, toilet room.

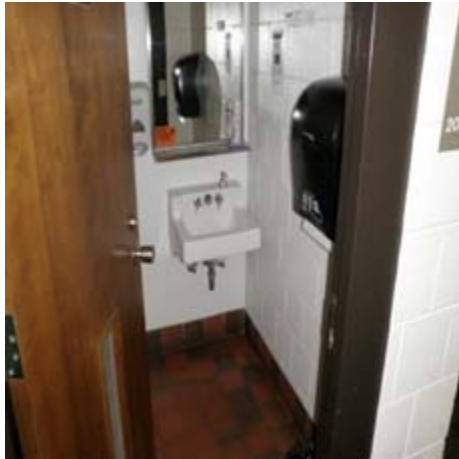
Figure 13, faculty toilet room.

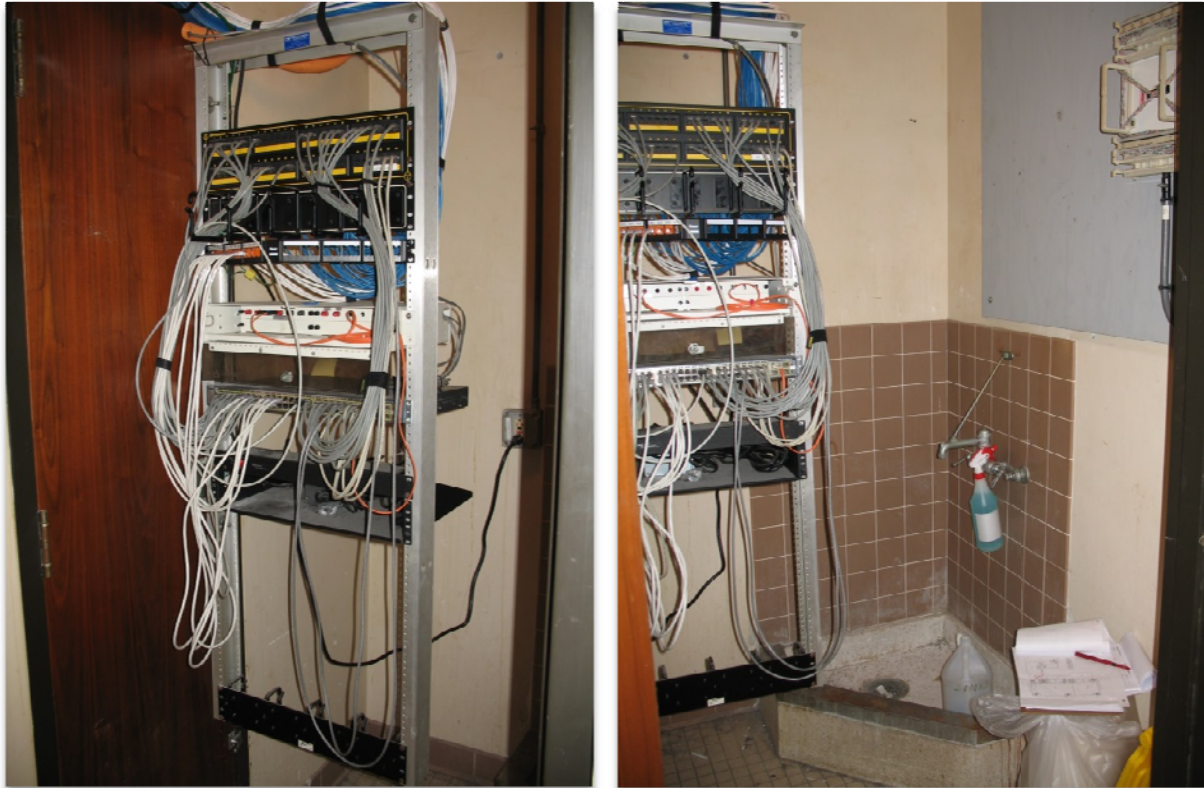
- Room Size and Layout
 - Telecommunication Rooms that are not sized properly to accommodate the communications infrastructure as the infrastructure grew have been noted in the Telecommunication Room Narratives. In a number of instances the cabling infrastructure and network equipment required have come to outgrow the room. In other cases, such as one particular Telecommunication Room in the Anderson Library for an example, the data rack has been installed in an old Custodial Room having a sink. Since floor space was limited a floor standing data rack has been modified so it could be mounted on the back of a door. The door the rack is mounted to is the door to the closet that the cable riser conduits are in. In order to

access the conduits you have to open the door and pull on the cabling that is installed to the data rack on the rear of the door. This telecommunication room should not have been constructed as such and will not allow adequate support of any future upgrade to the cable infrastructure for the floor it supports (See Pictures Below).

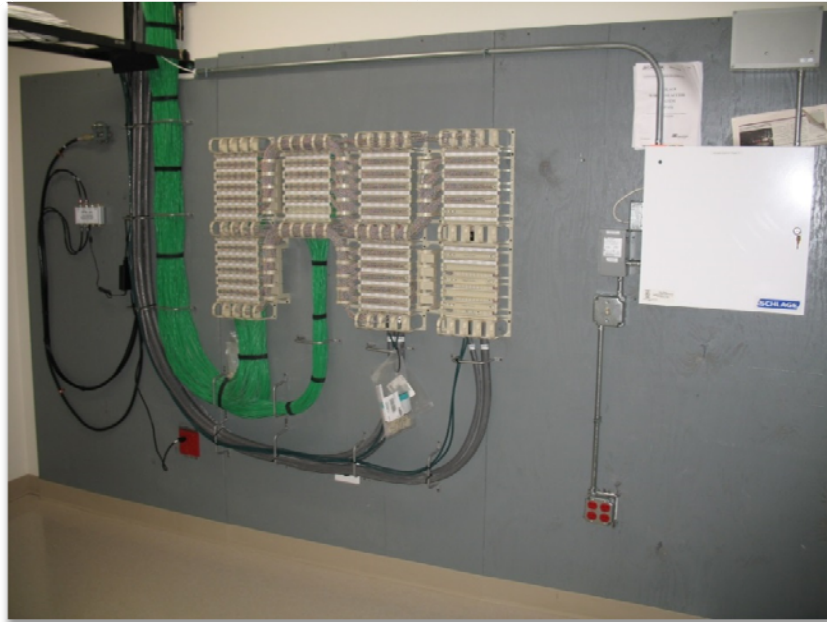
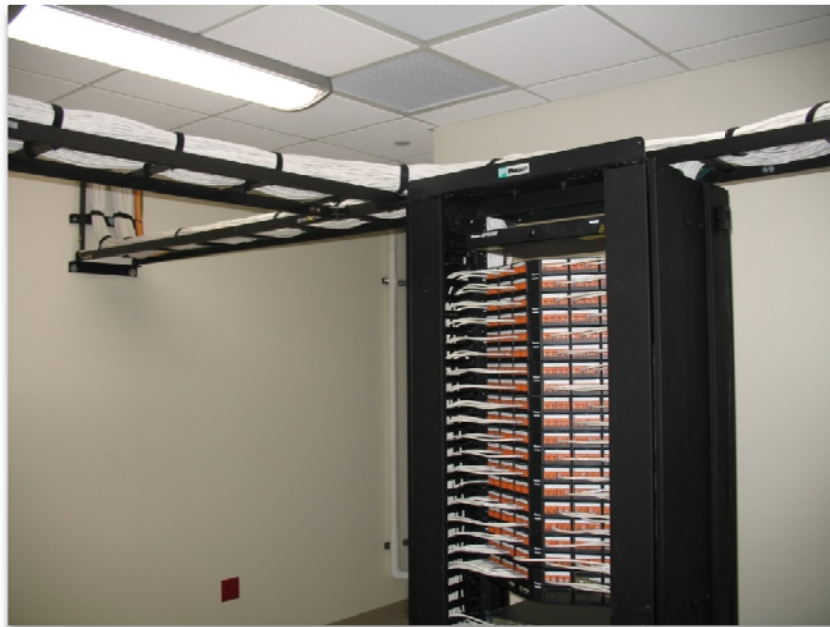
- Telecommunication Rooms should be dedicated rooms with proper cooling and lighting, similar to the rooms constructed for Hyland, Laurentide and Starin Halls (See Pictures Below of Hyland Hall 3rd Floor TR). This allows for better access control to the spaces and less chance that other mechanical or electrical systems installed within the rooms would have an adverse effect on the operation of the network. The following are standards based requirement for the development of a new Telecommunication Room:

- The room should be no smaller than 8ft. x 10ft. if serving an area 5000sqft. or less.
 - Ceiling heights within the room should be no less than 8ft. AFF.

- Doorways to the room should have full opening ability to 180° if permitted and be a minimum of 3ft. wide and 6.6ft. high.
 - Dust and static electricity should be avoided by installing tile vs. carpeting or, floor, walls and ceiling should be treated to minimize dust.

- Environmental control should be maintained 24 hours a day 365 days a year and maintain a positive pressure with a minim of one air change per hour. Temperature should be between 64°F to 75°F with the relative humidity in the range of 30% to 55%.
- Lighting should be coordinated with the equipment layout, especially overhead cable trays so fixtures are not obstructed. Light colored wall finishes can be used to enhance room lighting.

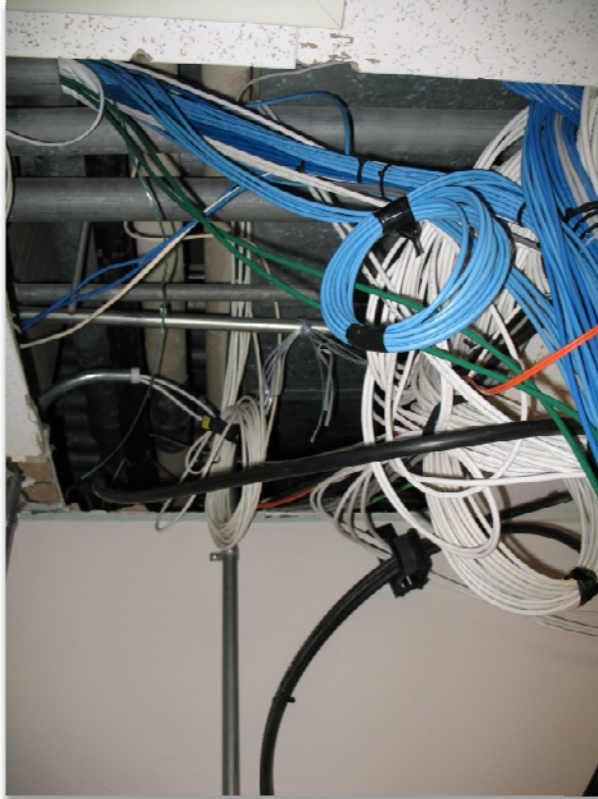
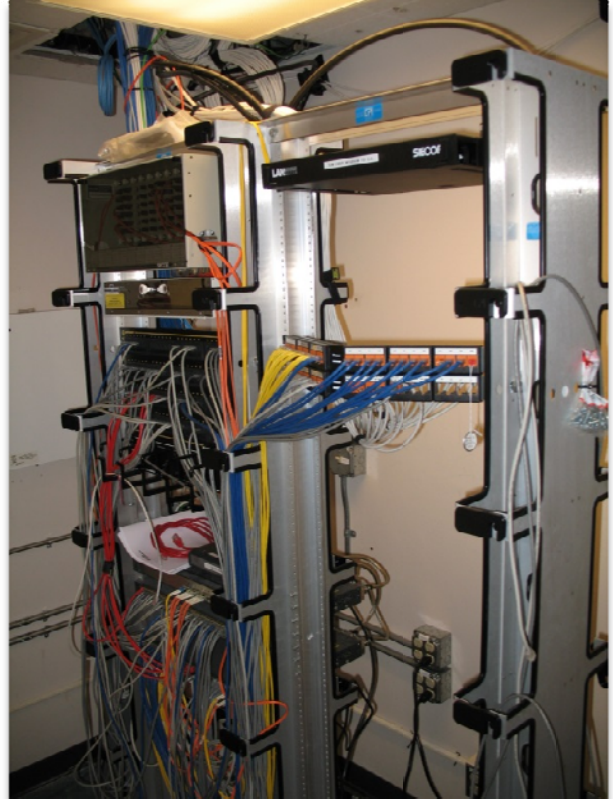
- Cable support
 - Cable support within many of the Telecommunication Spaces was inadequate or reaching beyond its capacity. In many rooms there were unmanaged slack coils of horizontal workstation, optical fiber and CATV cabling hanging directly above the data racks using tie wraps, D-rings, black electrical tape, or Velcro as a means of support. Cable tray or Ladder runway should be installed above the data racks to support cabling and provide slack management. These cable tray or ladder raceways should be sized based on current cabling capacity and future capacity needs. This becomes of the utmost importance as older category 5 and 5e cabling is replaced with higher performance category 6 cabling (See Pictures Below of TR 22 Center of the Arts).

- In many cases vertical and horizontal cable management within the data racks was either not present or not being utilized. Patch cords dangling down in front of network equipment will block airflow to the equipment and can cause cooling issues even for equipment in well air conditioned Telecommunication Rooms.

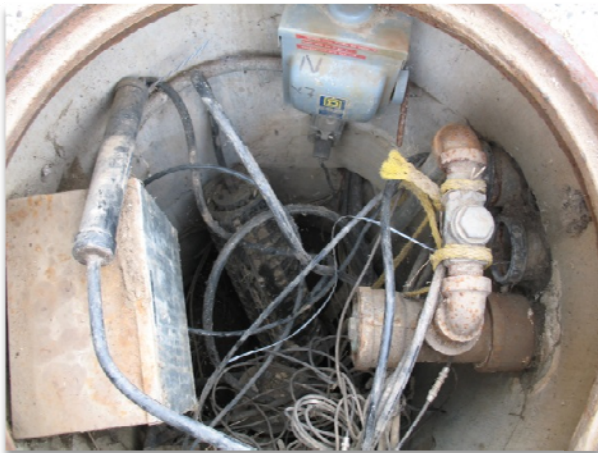
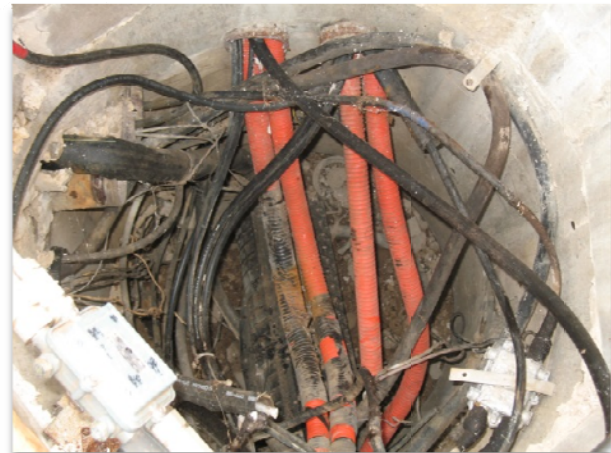
- Manholes and Handholes
 - Most Signal Duct Manholes surveyed were adequately sized with the exception of SX7, SX8, SX17, SX18, and S3. These Manholes appear to be older, much smaller and have more abandoned cabling than many of the other holes. Manholes SX7 and SX8 East of Hyland Hall should be phased out of use or made larger since it is impossible to get into these holes without damaging potentially active optical fiber or signal cabling (See Pictures below of SX7 and SX8). It appears based on the new signal duct installed and surrounding Manholes that this has already been identified and these two holes will eventually be empty. SX17, SX18 and S3 located just outside Goodhue going north should be easier to work in once all old Multimode and the existing abandoned CATV and Campus Signal cabling is removed.

- In most of the Manholes that were surveyed it was noted that an extreme amount of cable slack was coiled and left in each hole. This coiled cable slack in most cases was not secured to the wall of the hole; it was coiled around the inside of the hole or lying on the bottom of the hole. Most holes surveyed had metal strut built into the wall to support the installation of cable support hardware within the hole to facilitate an organized means to address cable slack and cable support thru the hole. This existing channel is underutilized.

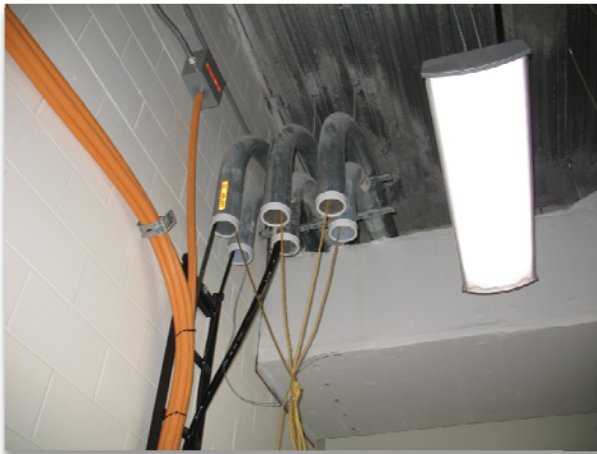
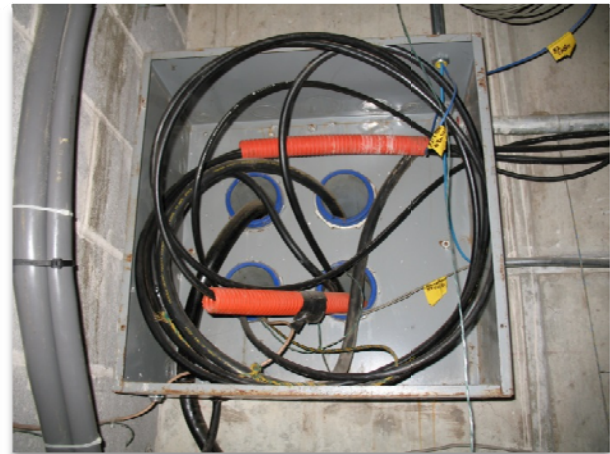
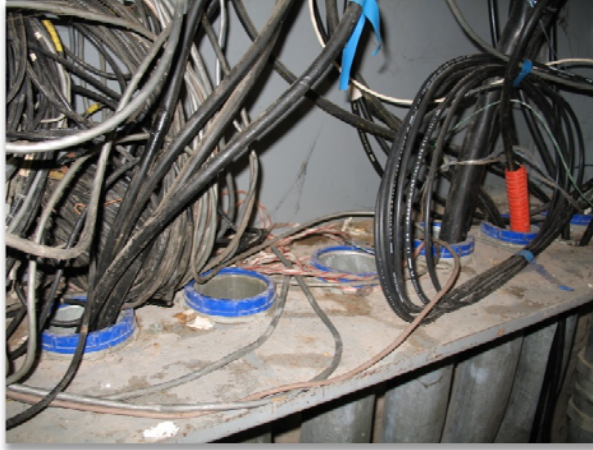
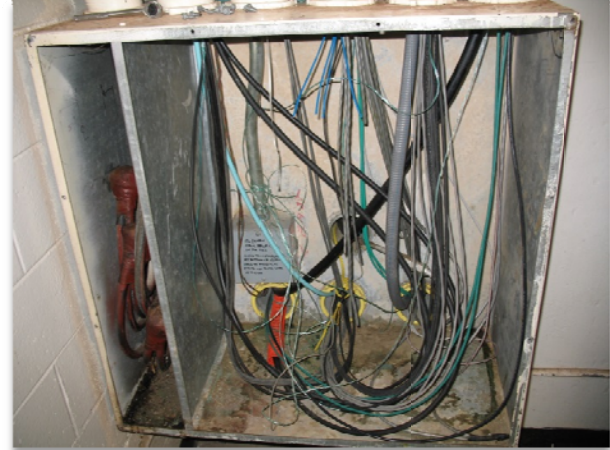
- As a minimum all Signal Duct Bank conduits should be plugged with Duct Seal designed for that purpose to allow easy reentry in the future at the entrance to each of the buildings to prevent gases, rodents, insects and/or water from entering the building. Not a single Signal Duct Bank conduit was plugged at the entrance facility in the buildings surveyed. Most of the Signal Duct Bank that was examined was installed to a junction box mounted at the entrance inside the facility but not one of these junction boxes had a gasket on its cover or duct seal installed to the conduits within preventing potentially toxic gases, rodents, insects and/or water from entering the building. In 25% of the cases the junction box covers were not installed or missing (See Photos below from Hyland Hall, Anderson Library, Hyer Hall, Food Service Area In Perkins Stadium).

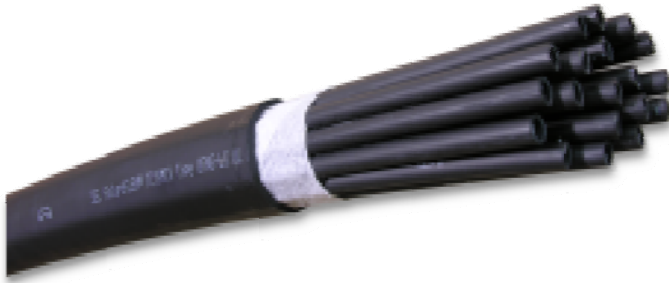
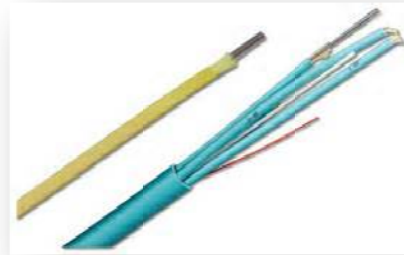
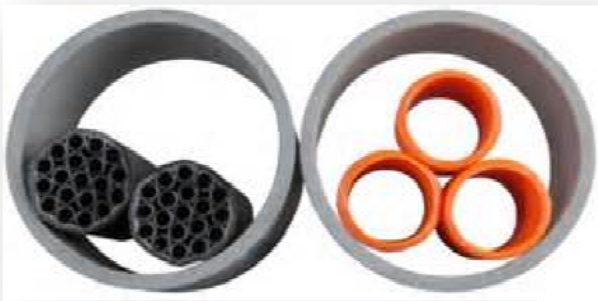
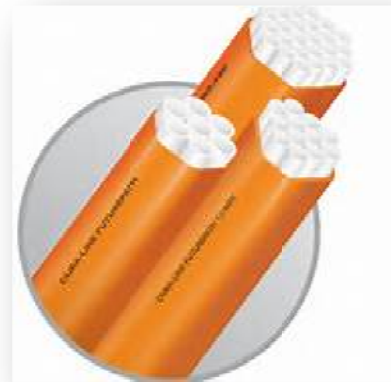
- Once a solution is chosen either Sumitomo FutureFLEX or AFL/Duraline FuturePath the course needs to stay true to one solution or the other. The two solutions are not easily combined.

AFL/Duraline claims their fiber cable solution can be installed in Sumitomo's Tube cable system; however it would be difficult to warranty the combined solutions.
